# Observations and Reported Effects of the February-April 2008 Mogul-Somerset, Nevada Earthquake Sequence

6/20/08

Craig M. dePolo, Research Geologist  
Nevada Bureau of Mines and Geology  
University of Nevada, Reno

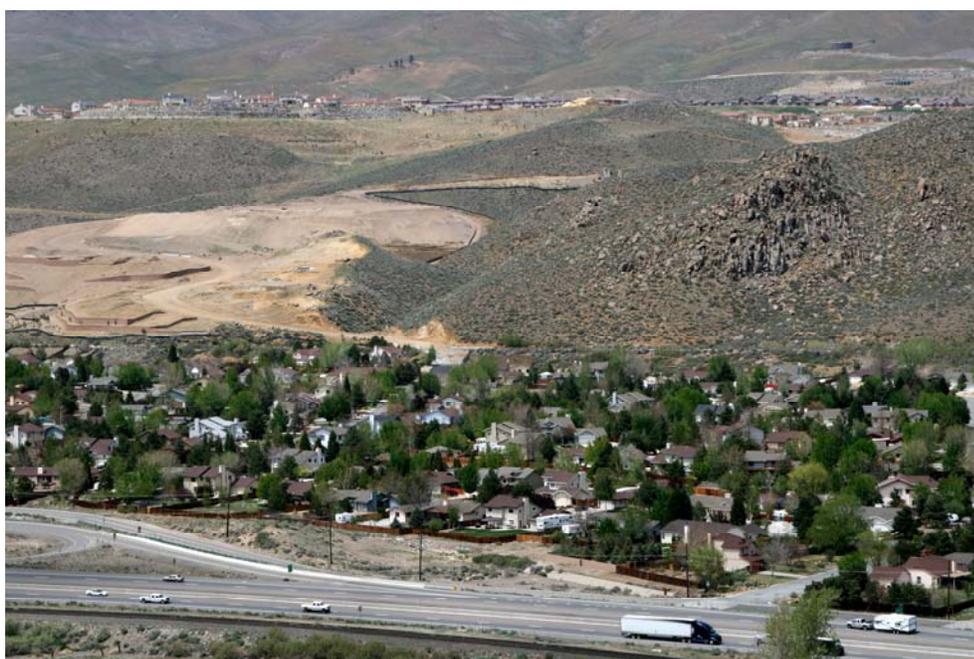
**Figure 1** Two communities directly overlie the earthquake zone, Mogul in the foreground, and Somerset shown in the distance in the upper part of the image. Interstate 80 is shown at the bottom. The view is to the northwest.

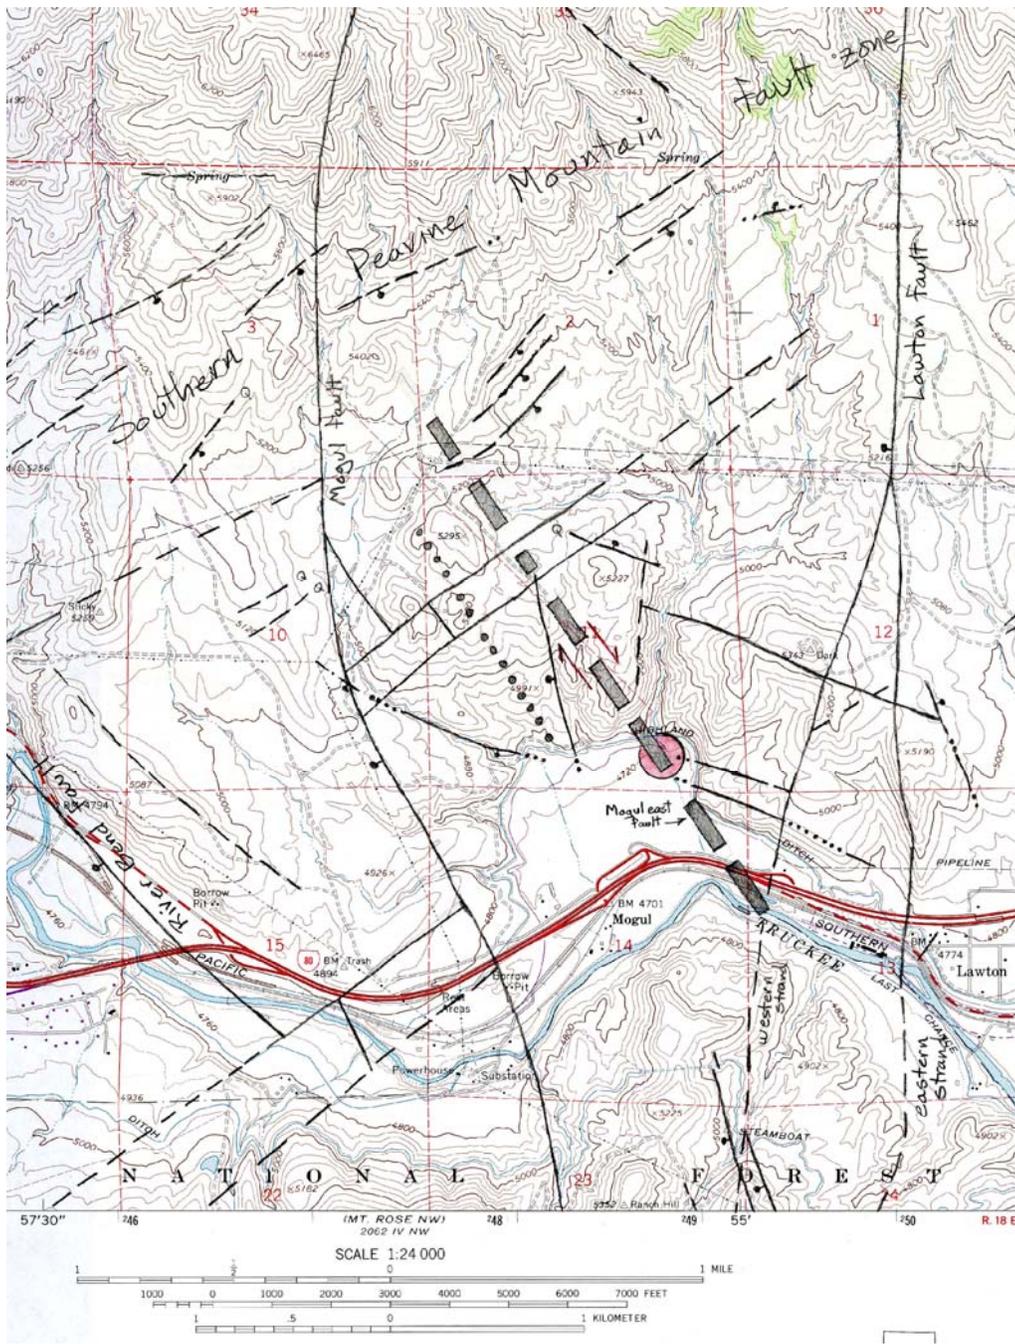
**Figure 2**  
 Preliminary sketch map of faults from Bell and Garside (1987) and Cashman and Trexler (unpublished research) compiled on the Verdi Quadrangle. These bedrock faults are solid lines where mapped and are dashed where inferred. The thick, solid gray dashed line is the upper part of the moment magnitude 5 earthquake rupture (herein named the "Mogul east fault"). The red circle is the epicenter (from Ken Smith, Nevada Seismological Laboratory). The alignment of dots is a second, early trend of seismicity, is called the western strand of the Mogul east fault. The southern Peavine Mountain fault zone is a structural trend or zone of faults near the southern flank of Peavine Mountain, shown as the northeast striking faults near the top of the map (taken from

Bell and Garside, 1987) that dip to the southeast (indicated by the balls). The eastern continuous, north-south fault is from Cashman and Trexler (unpublished research) and is herein named the Lawton fault; this fault splays to the south into eastern and western strands. The magnitude 5 earthquake rupture appears to have nucleated near the intersection of the Mogul east fault and a more westerly set of faults mapped by Bell and Garside (1987). The southern end of the rupture may be an intersection with the western strand of the Lawton fault and the northern end may be a dipping intersection with the southern Peavine Mountain fault zone (a view of the relocated aftershocks shows a possible southeast-dipping truncation to the seismicity). Thus, there was structural control to the hypocenter of the Mw 5 event, its endpoints, and its size.

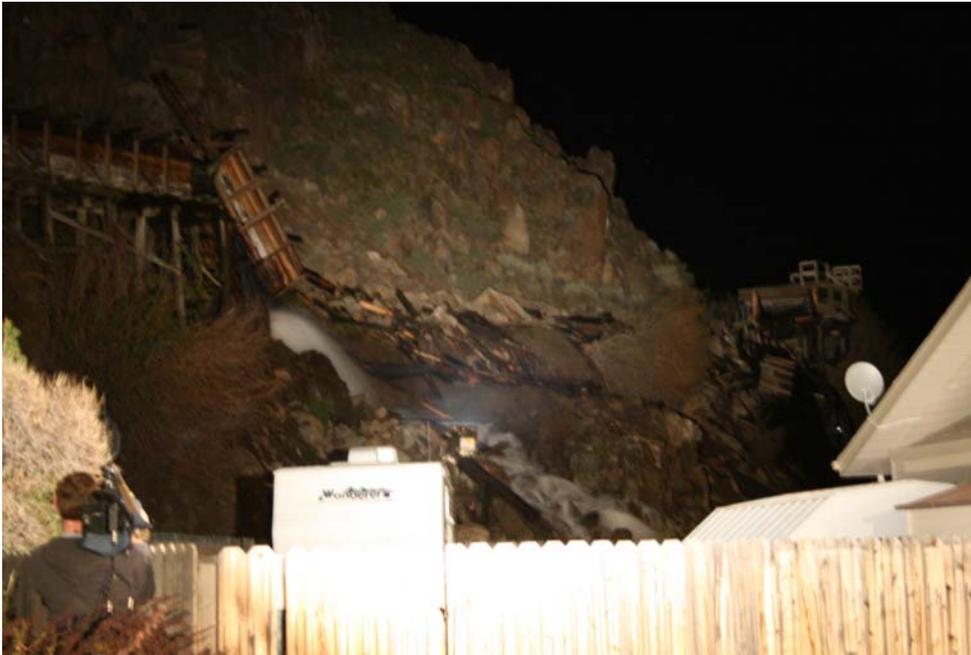
Rocks fell in and partially blocked a water canal and section of its flume was broken by a rock fall, both instances sending water flowing through the backyards of homes (**Figure 10** -see utilities section). Quick action by local water company employees diverted the canal water upstream into a drainage ditch and turned the canal off to avoid further damage.

**Figure 10** A rock fall broke the water flume and caused water to flow near houses.

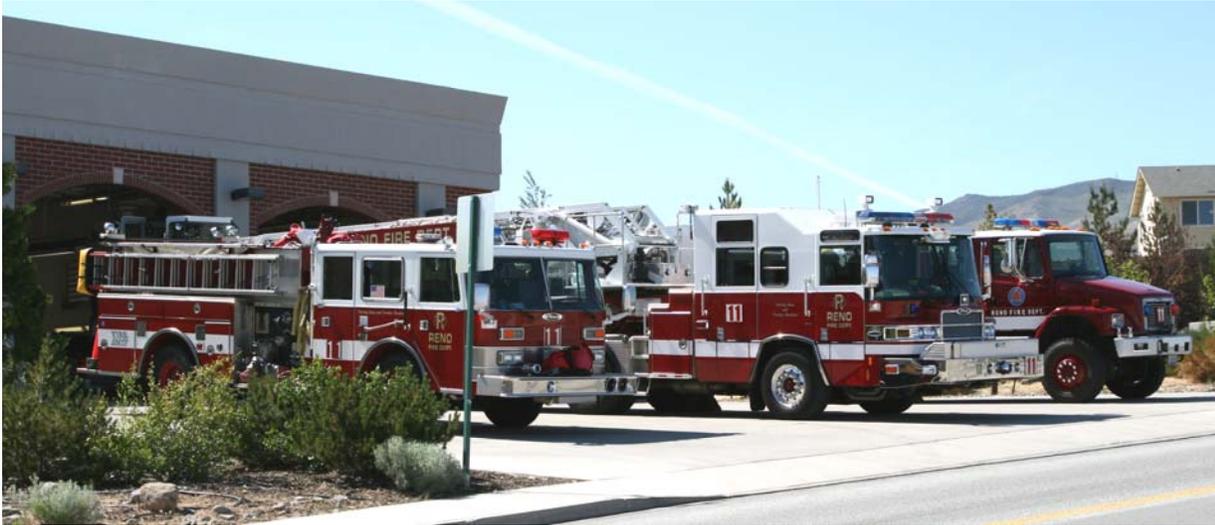
**Figure 11** Fire engines were pulled out of fire houses following a series of magnitude 3+ earthquakes within 12 hours. This occurred in June and the nice day made this an easy preparedness action. In a worst case scenario where the doors are stuck with equipment behind it, firefighters felt they could cut off a jammed or otherwise un-opening door in about three minutes.

As earthquake magnitudes increased in the sequence, so did the response readiness, as emergency responders and managers keyed into the threat. In **Figure 11** a response of a local fire station to three magnitude 3+ earthquakes in the morning was to bring the fire equipment out of the firehouse during the day until the earthquakes settled down. The escalating sequence created a natural anticipation of a larger earthquake.

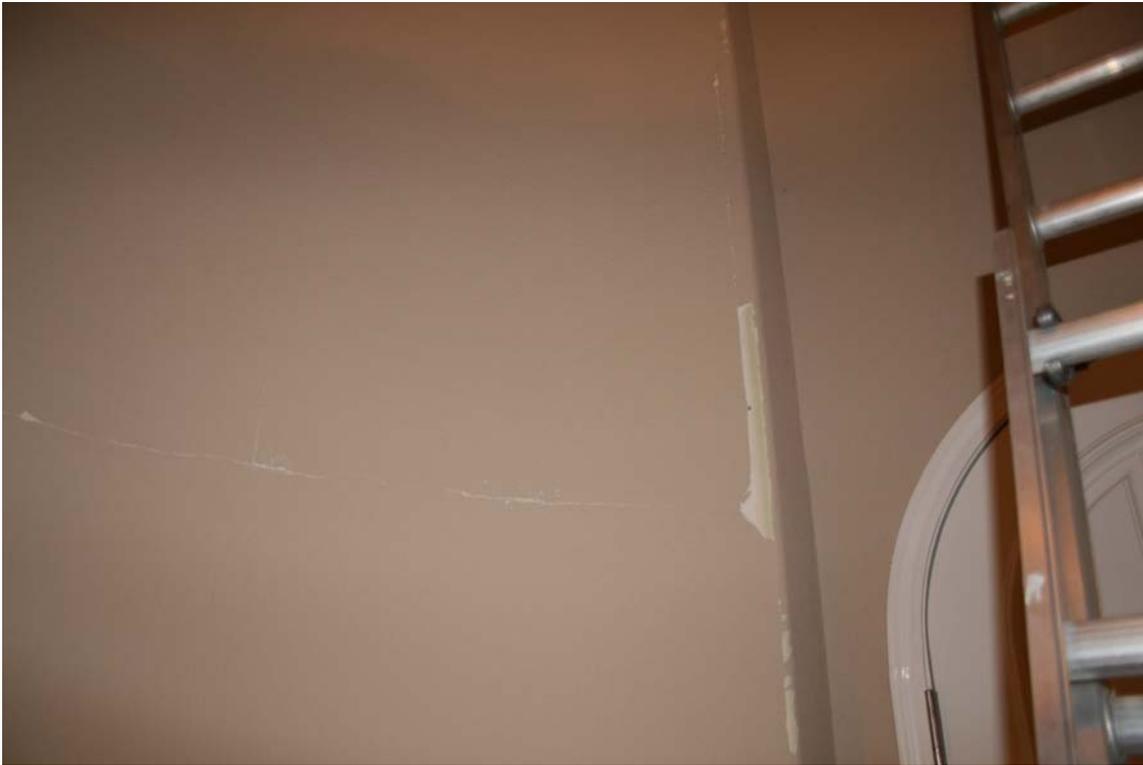
**Figure 12** Cracking of plaster and paint in entryway of a home.

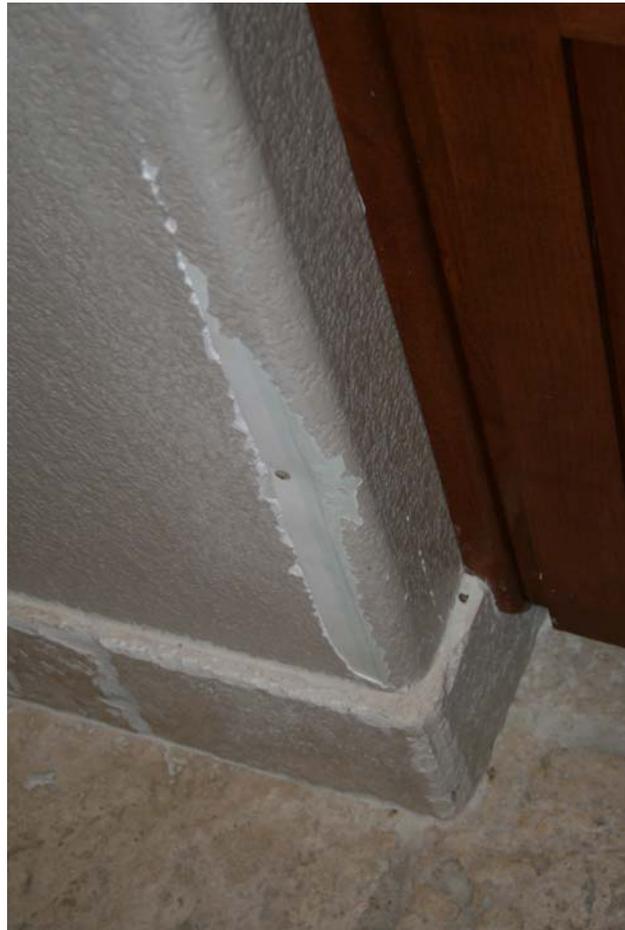
**Figure 13** Cracking and chipped paint was broken away from the seam from rocking motion of a house.

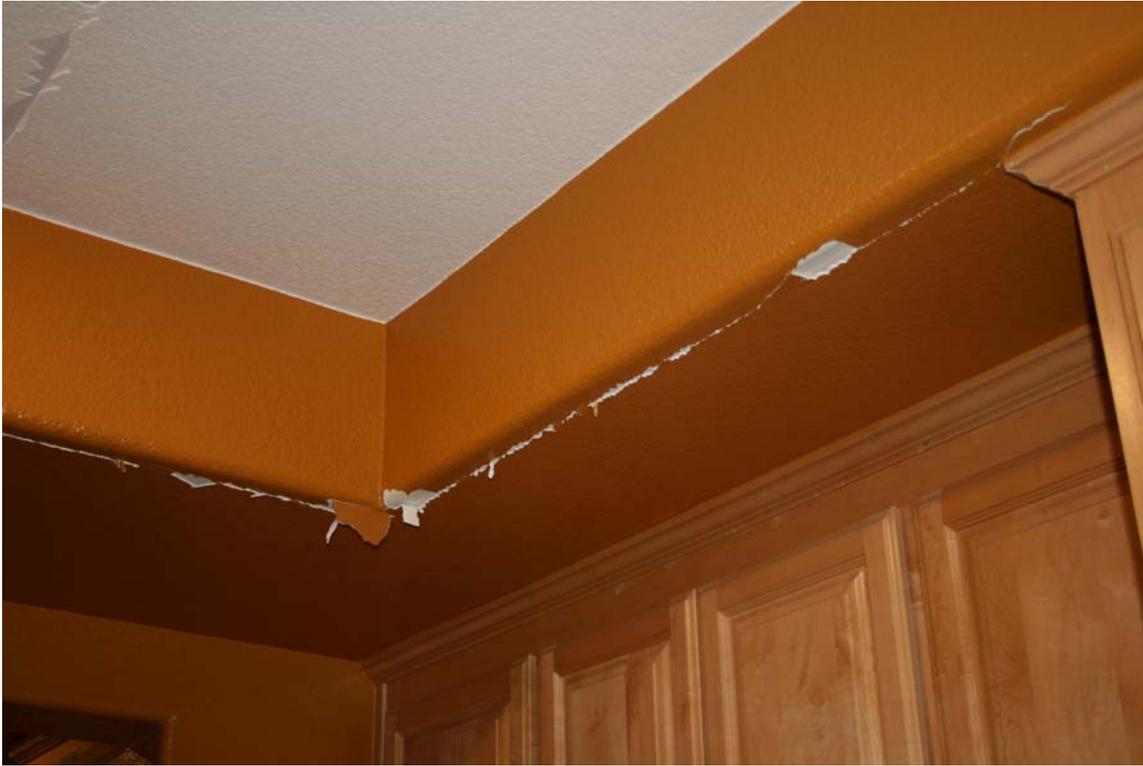
**Figure 14** Damage to plaster and paint along seams in a kitchen from rocking motion of house.

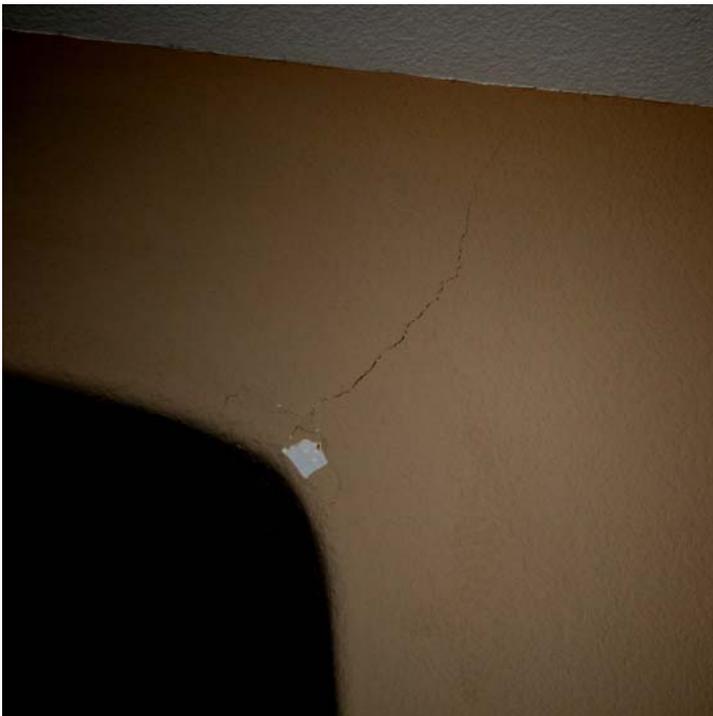
**Figure 15** Common position of diagonal cracks near top corner of entryways or openings.

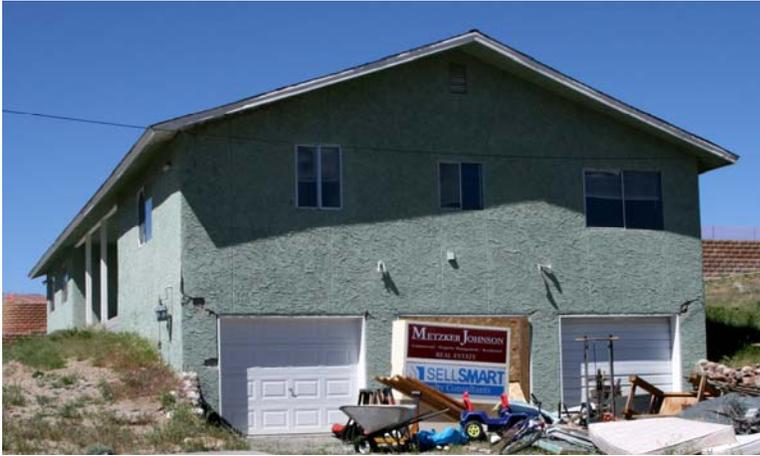
**Figure 16** This house was rocked back and forth, cracking the stucco in the lower part, near the top of the three garage door openings. The slope created a small vertical irregularity in the structure and the garage door openings acted as a relatively soft first story.

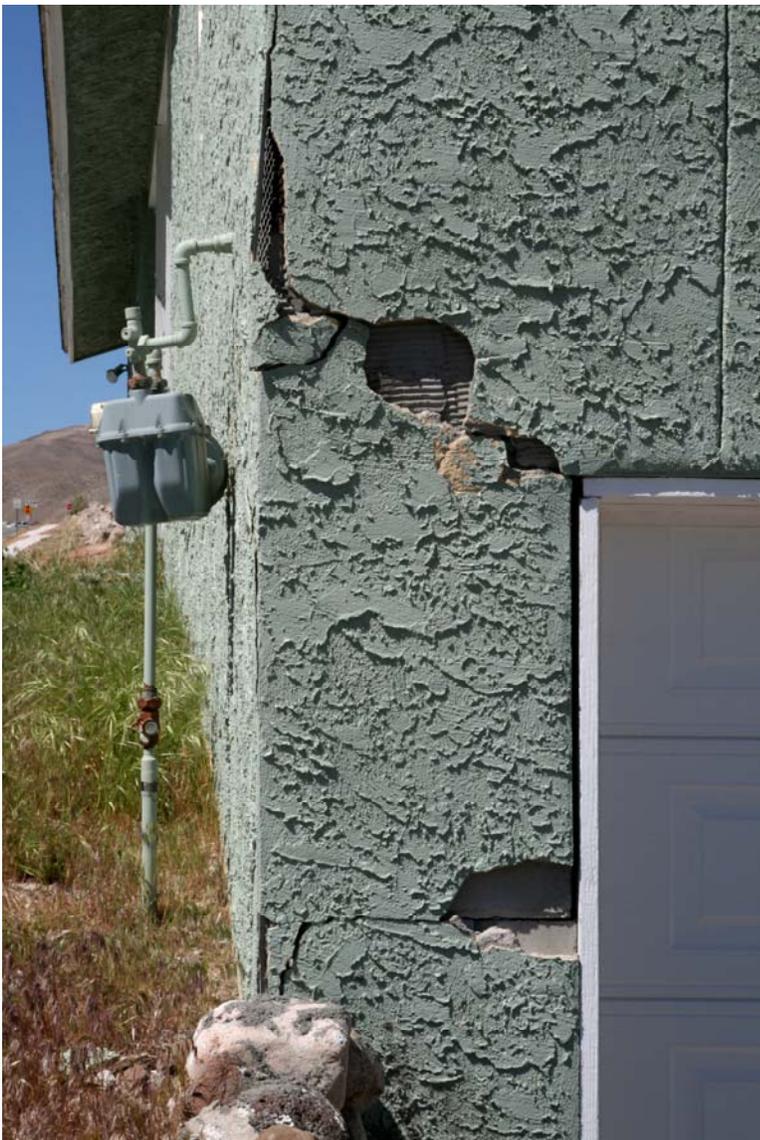
**Figure 17** Close up of cracked stucco from rocking motion of house in figure 16. Note the gas meter that apparently flexed along with the motion successfully.

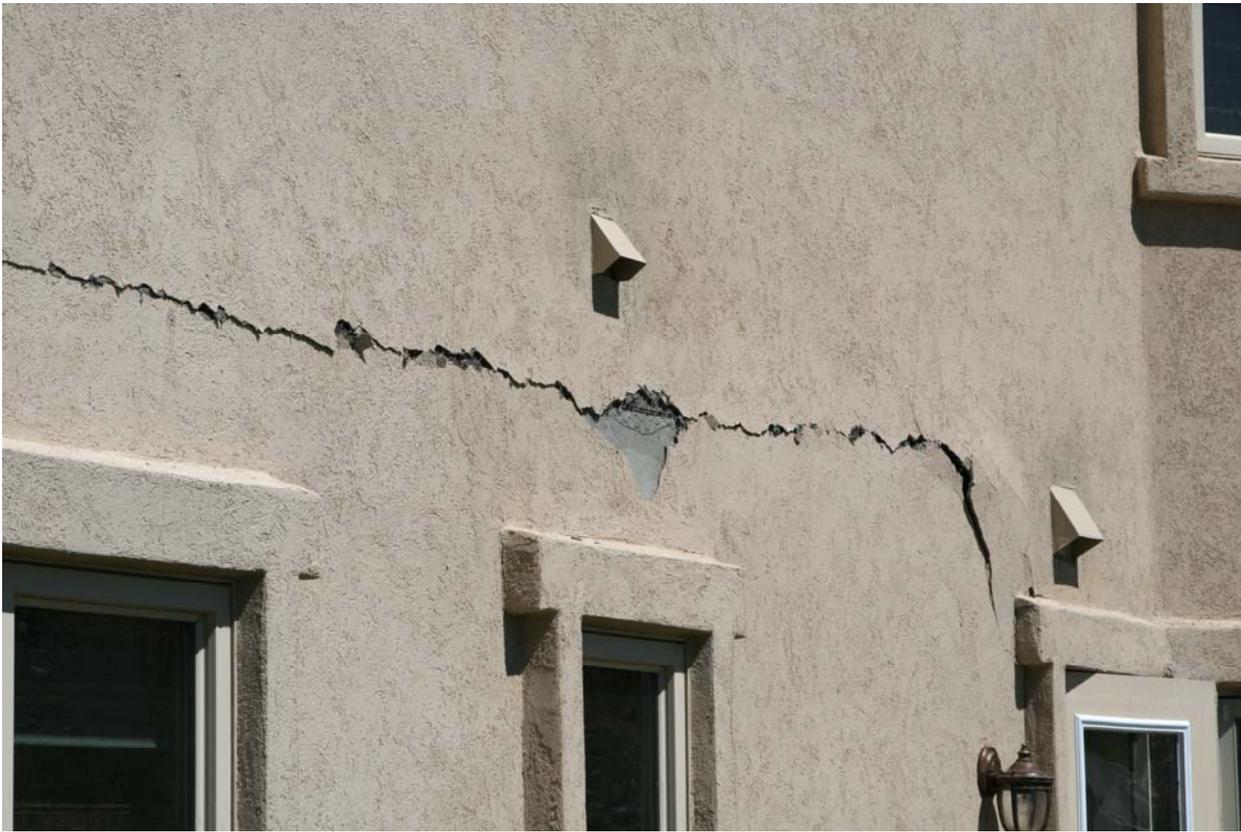
**Figure 18** Horizontal fracture in stucco exterior of a house.

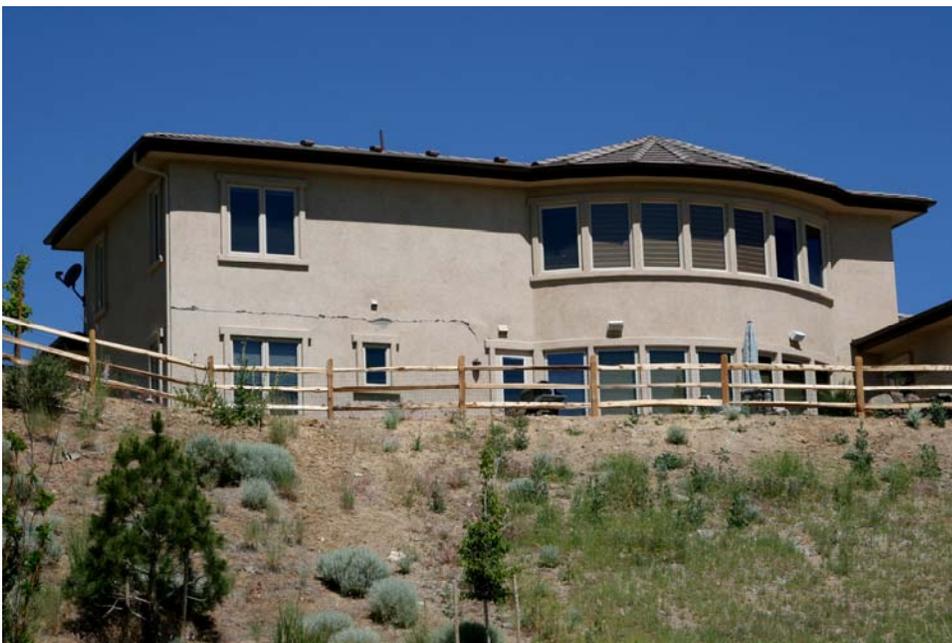
**Figure 19** Overview of house shown in figure 18. Crack is on the left side of the building between the first and second stories.

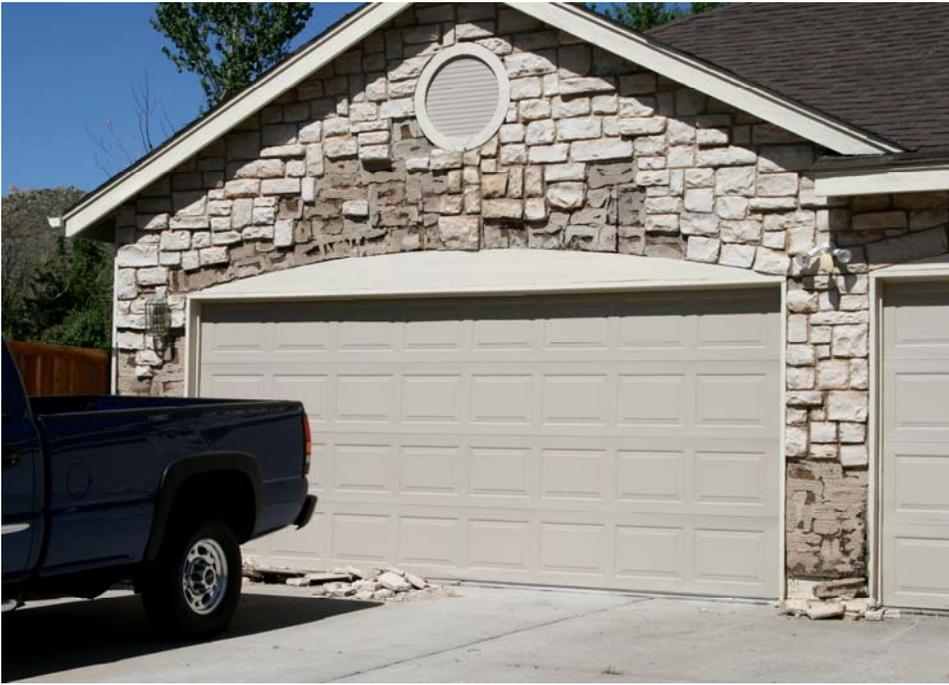
**Figure 20** Decorative rock was popped off the garage, caused by the movement and distortion of the garage during shaking.

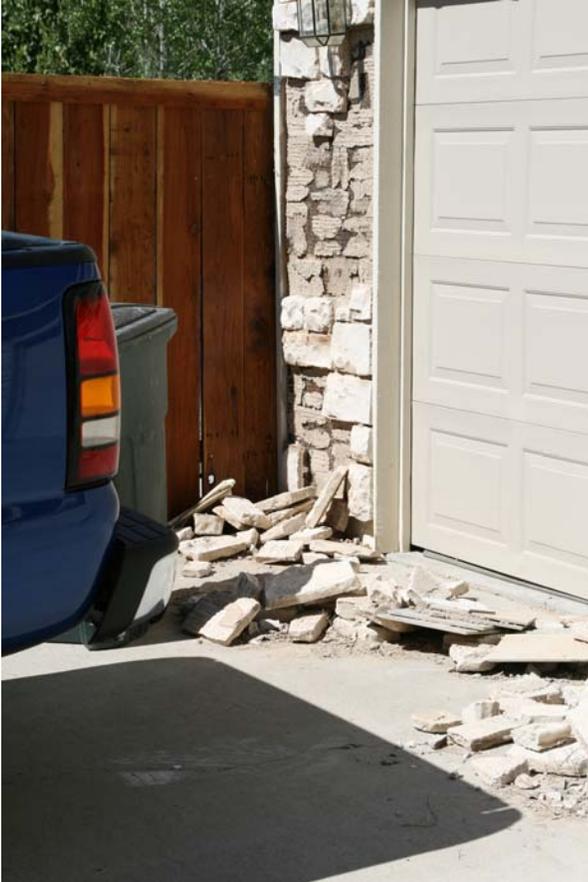
**Figure 21** Detail of dislodged and damaged decorator rock.

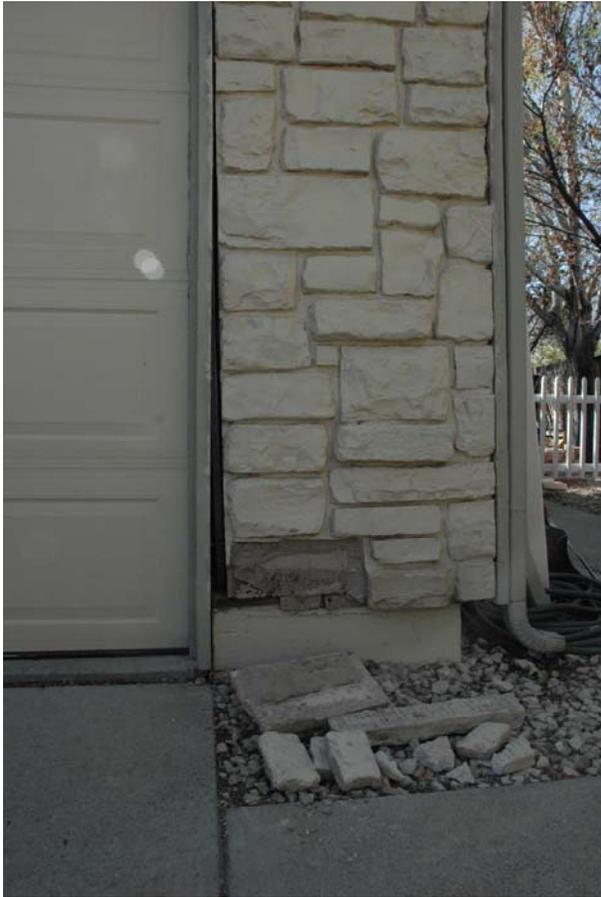
**Figure 22** Corner of garage wall is displaced off the mud sill and a few decorator bricks have been knocked off (photo by John Anderson)

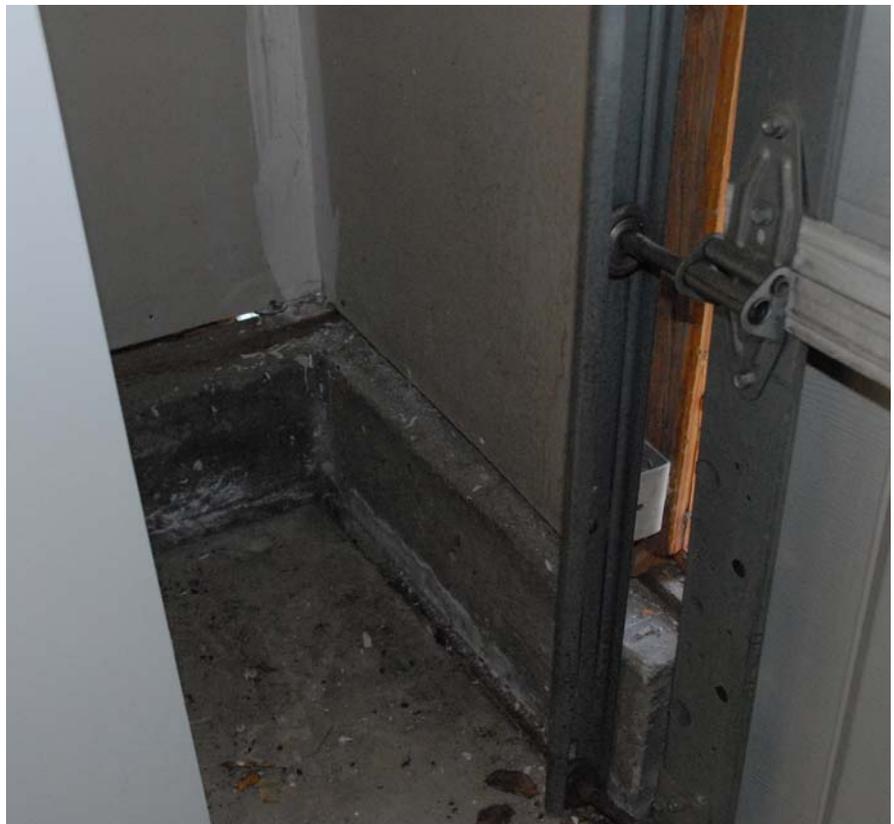
**Figure 23** Inside view of displaced wall shown in figure 22. Offset at the side of the garage door and at the corner of the wall of about an inch can be seen; note the daylight showing just above the mud sill (photo by John Anderson)

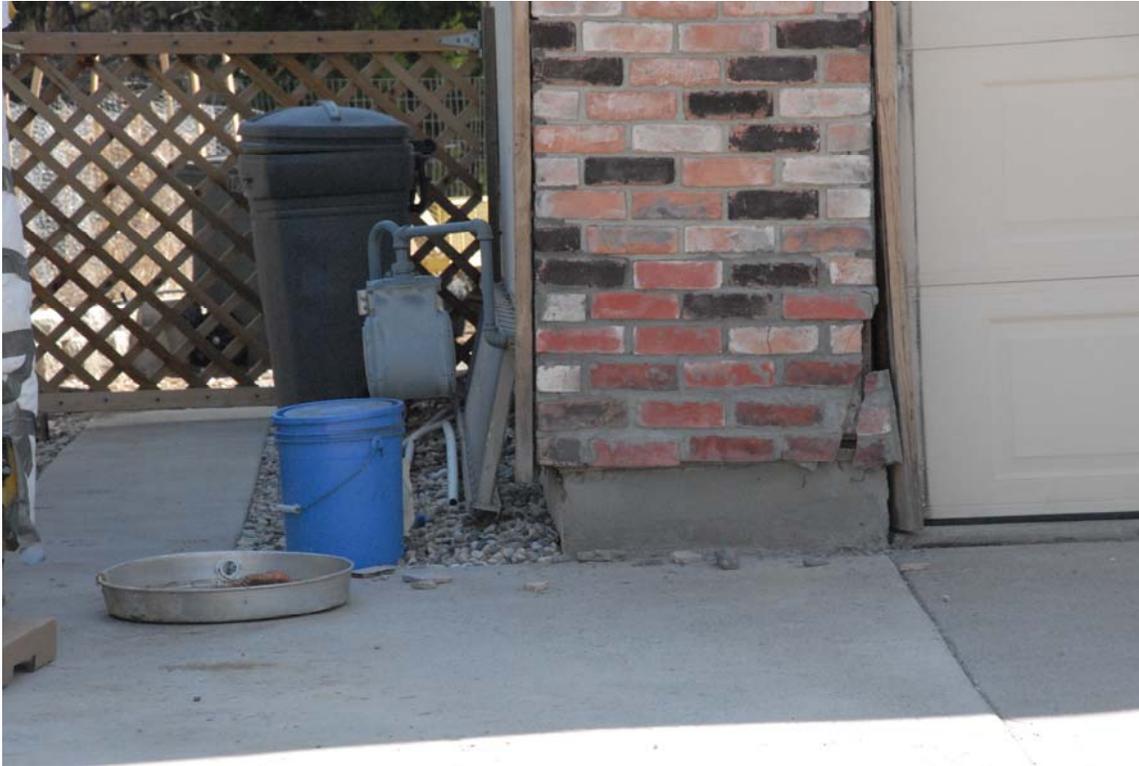
**Figure 24** Corner of garage wall displaced to left off its mud sill. The gas meter handled movement successfully. (Photo by John Anderson)

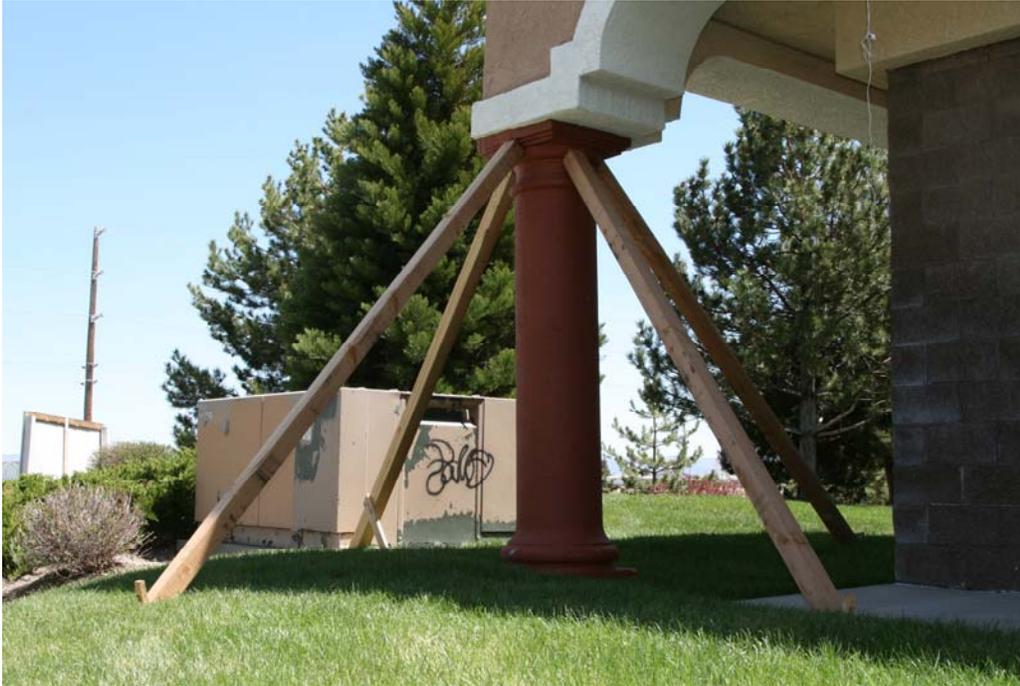
The column of one store appeared displaced slightly and was braced for reinforcement with four-by-fours (Figures 25 and 26).

**Figure 25**  
Pillar displaced at top slightly is braced for aftershocks.

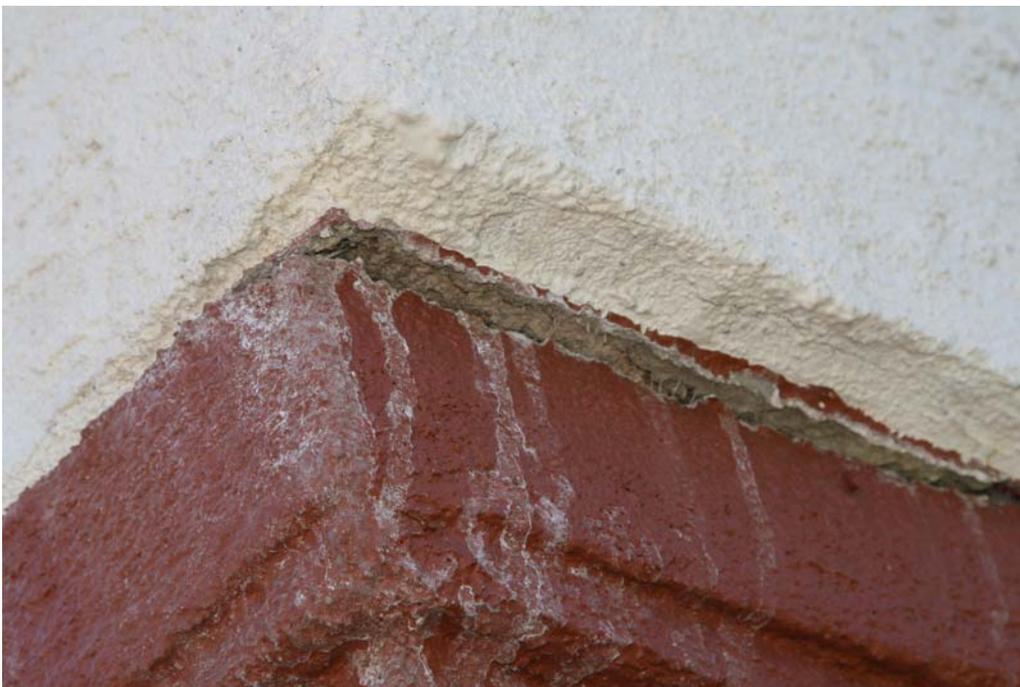
**Figure 26**  
Top of pillar shown in figure 25 displaced from top about 2/10<sup>th</sup>s an inch.

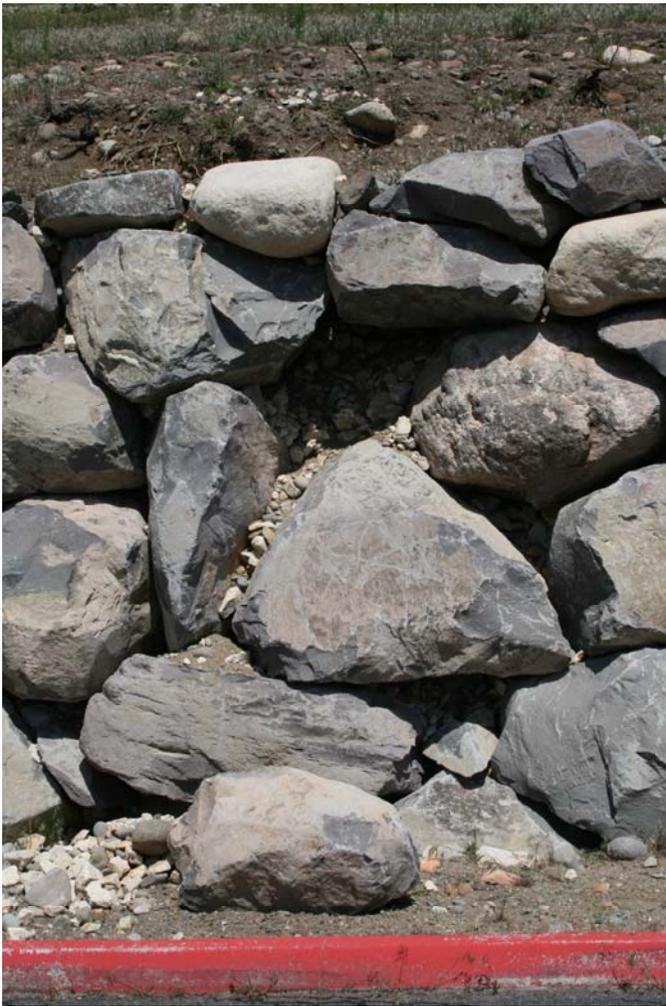
There are a large number of earth-fill pads and rockery walls in the earthquake area to support the foundations of homes in this hilly landscape. Some rockery walls I observed had individual or a few rocks that fell off the top, or out of (**Figure 27**), the

**Figure 23** Boulder that fell out of the middle of a rockery wall (boulder is laying on the ground in front of the wall, closet to the red curb).

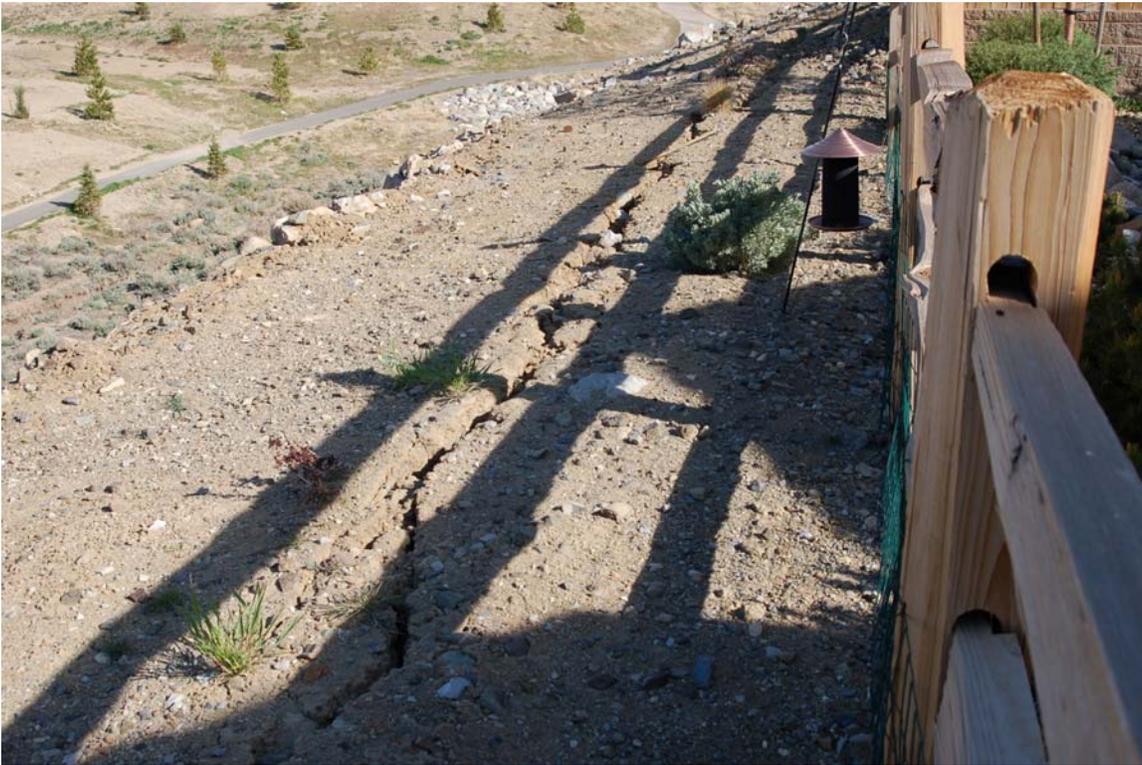
In one case, the crack appeared due to settlement of the fill adjacent to the rockery wall, or the wall and fill settled together in places (**Figures 28, and 29**). This crack was over 320 ft (100 m) long, with vertical offsets as much as 7 inches (17 cm) across it, although most of the crack didn’t show visible displacement. The crack was mostly continuous, but was discontinuous towards the ends. On one end, discontinuous cracks stepped back, but remained subparallel to the larger rock face, even though the slope curved back.

**Figure 28** shaking and settlement fracture along the upper part of a large, three-tiered rockery wall. Total settlement was about 7 inches (17 cm) in places.

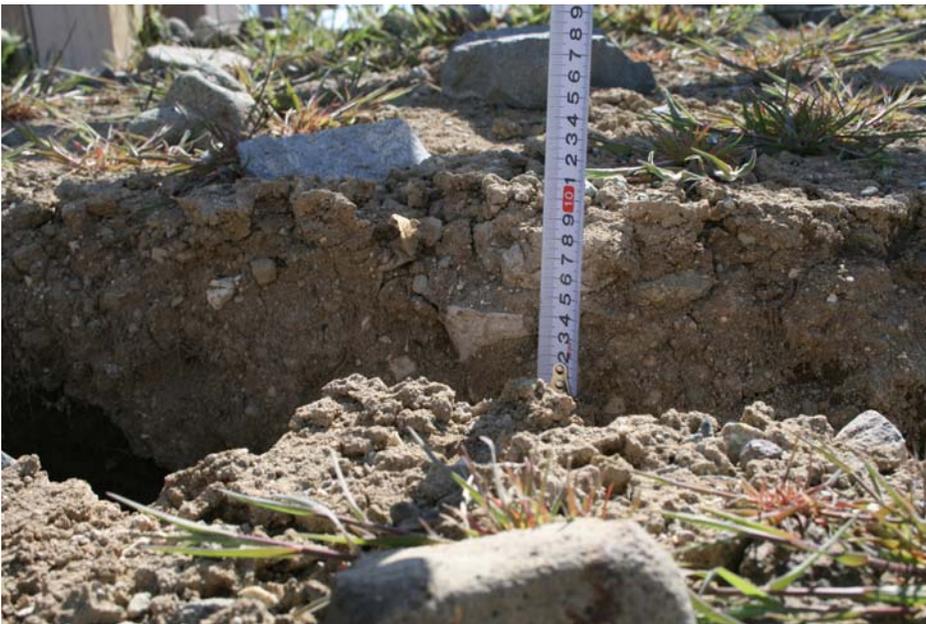
**Figure 29** Approximate settlement of fill adjacent to the rockery wall in figure 28; scale is in centimeters. Here the scarplet is about 4 inches (10 cm) high.

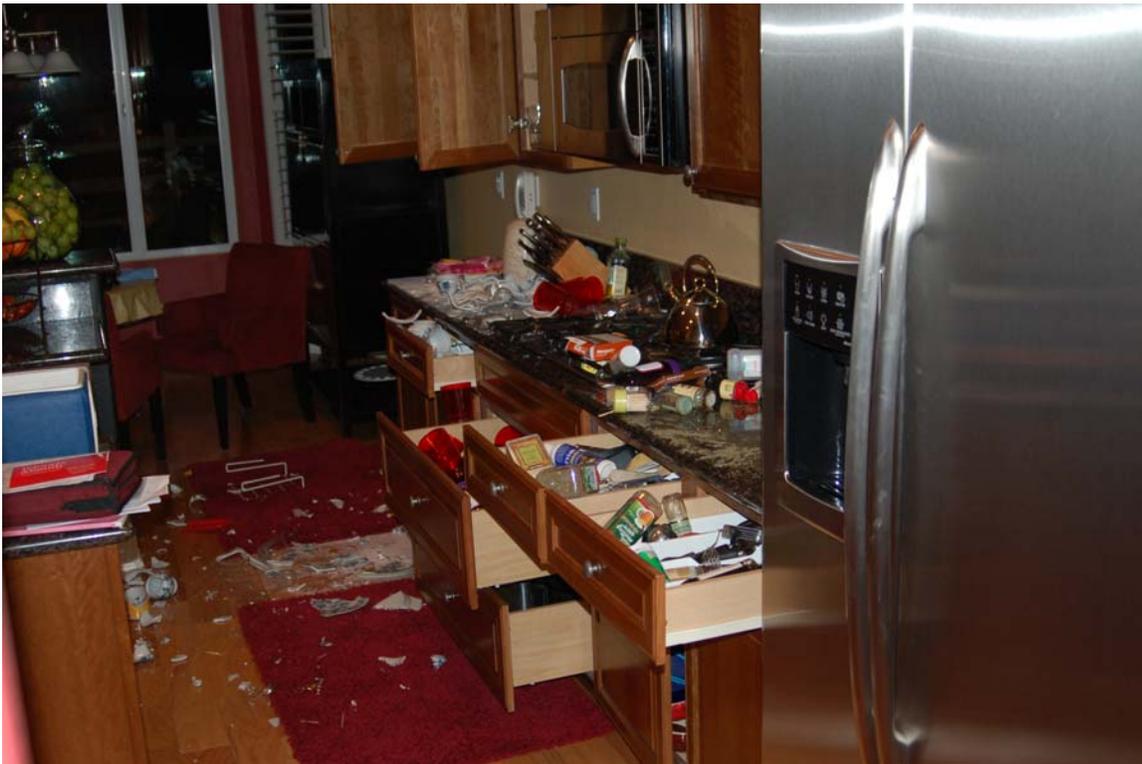
**Figure 30** Broken dishes and cups and drawers open in kitchen from the main shock. (photo by Terry Nielsen)

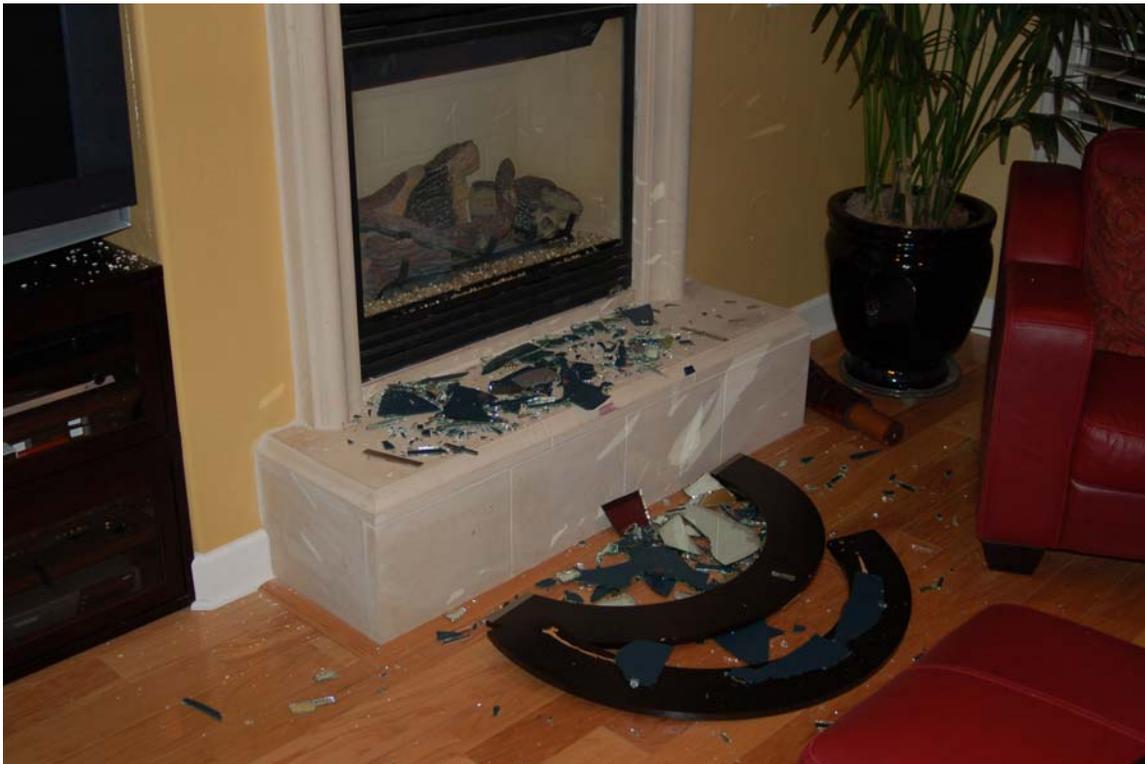
**Figure 32** Fallen and broken mirror (photo by Terry Nielsen).

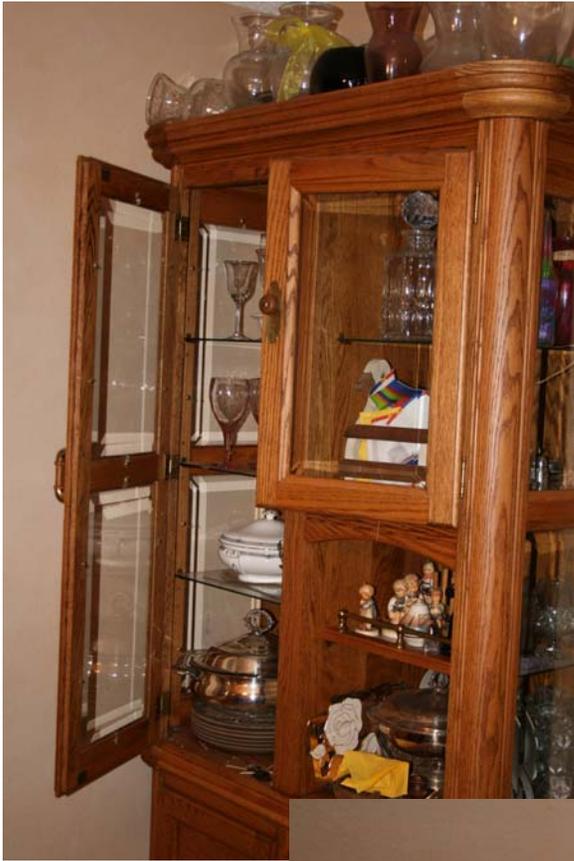
**Figure 33** China cabinet that was attached to the wall, but the doors opened and some glasses fell out, breaking on the floor. Amazingly, the empty vase collection on top of the cabinet survived.

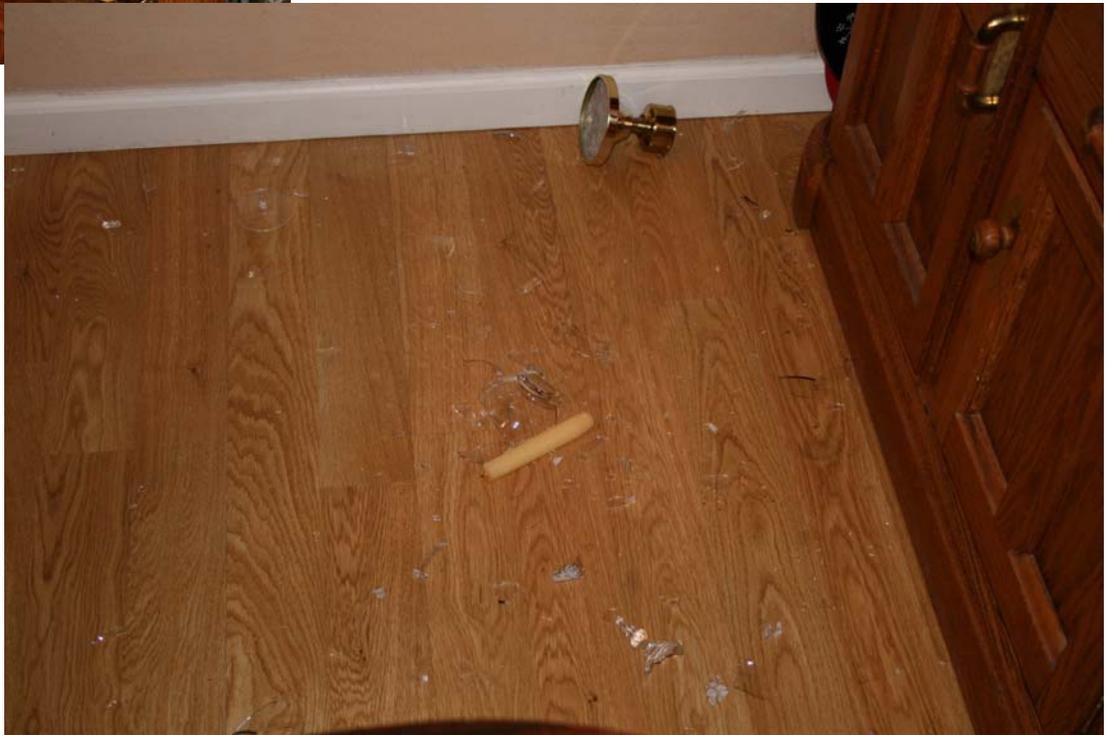
**Figure 34** Broken glasses on the floor from the china cabinet shown in figure 33. During the earthquake the occupant ran through the house in slippers over glass on the floor to check on their kids.

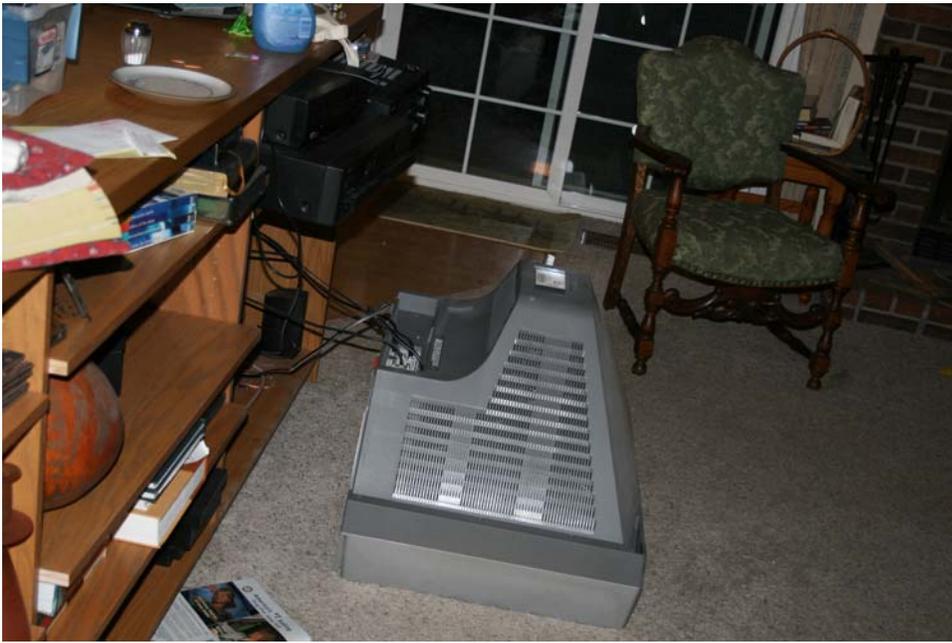
**Figure 35** Television flopped over from the earthquake. The low position of the television avoided major breakage and a significant safety threat.

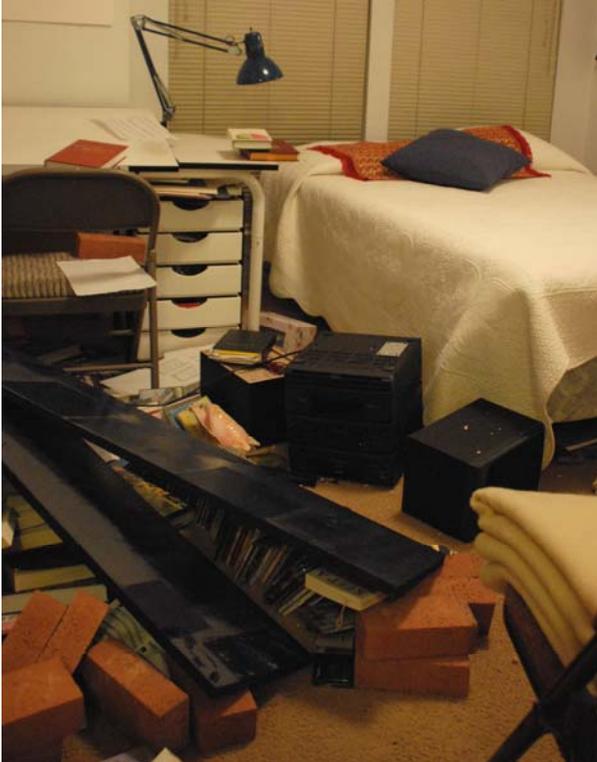
**Figure 36** Brick and wood shelving that collapsed from shaking. (photo by John Anderson)

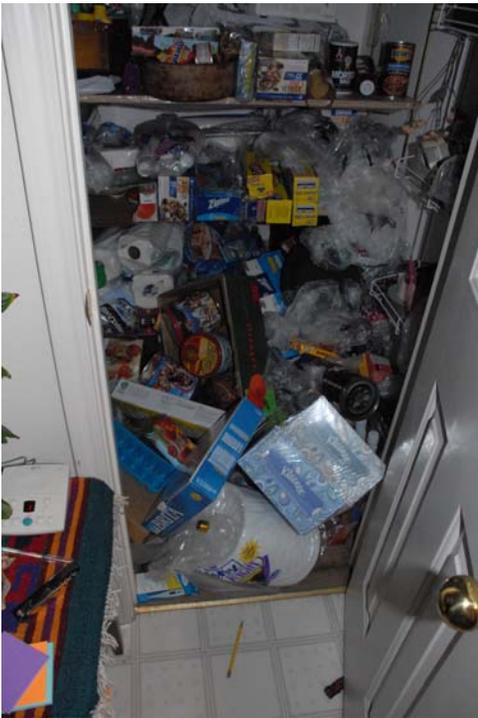
**Figure 37** Dislodgement of some items in a pantry. This is usually an acceptable misfortune of an earthquake. The cost is generally cleaning it up and loss of some broken items. More breakable and heavier items can be stored lower and the lighter items, like paper towels, can be stored higher to minimize losses. (photo by John Anderson)

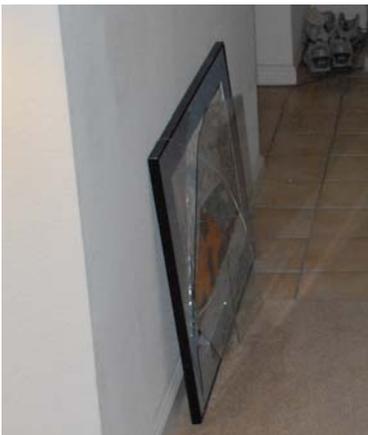
**Figure 38** Fallen picture with broken glass cover. (photo by John Anderson)

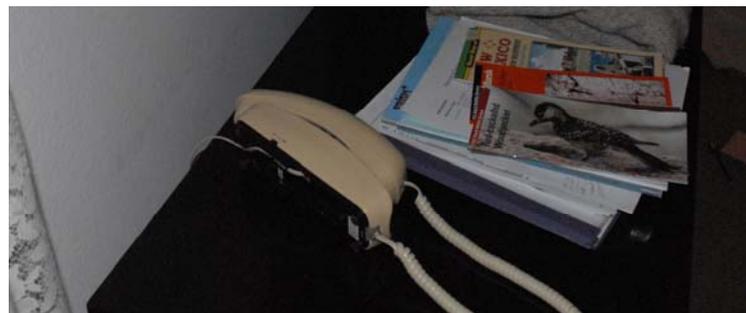
**Figure 39** Telephone knocked over by shaking and with the receiver “off the hook”. This affect likely caused a telephone line to be taken up for a period of time. In the post-earthquake inspection of a house, all telephones that are knocked off the hook should be placed back on, or unplugged to avoid further disruption from aftershocks if it is a secondary or generally unused telephone (photo by John Anderson).
