# Observations and Reported Effects of the February-April 2008 Mogul-Somerset, Nevada Earthquake Sequence

6/20/08

Craig M. dePolo, Research Geologist  
Nevada Bureau of Mines and Geology  
University of Nevada, Reno

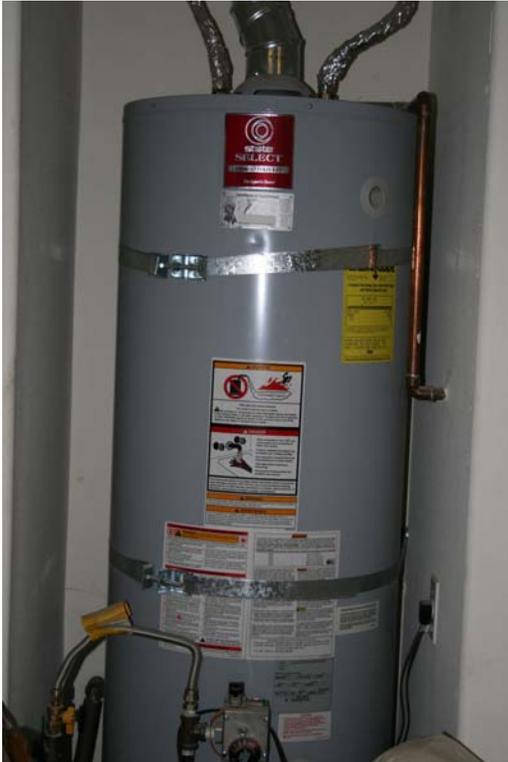
**Figure 40** Water heater subjected to the moment magnitude 5 event. Double strapping of the heater helped it stay in place. The upper strap has been loosened during the shaking and needs to be slid up straight and re-tightened. The straps do quite a bit of work holding the water heater up during an earthquake and need to be inspected following an event for any adjustments.

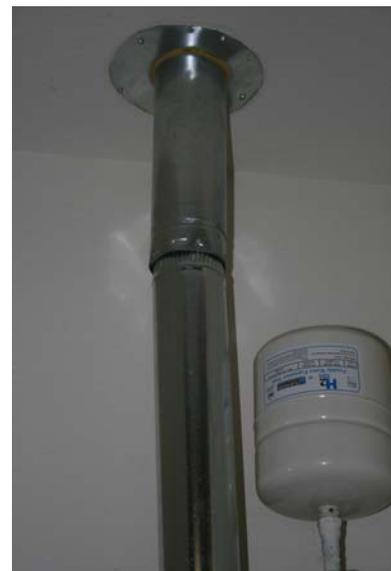
**Figure 41** Exhaust pipe of a gas water heater showing a slight misalignment from the earthquake. The exhaust pipe also needs to be inspected following earthquake shaking because an exhaust leak can lead to carbon monoxide gas poisoning.

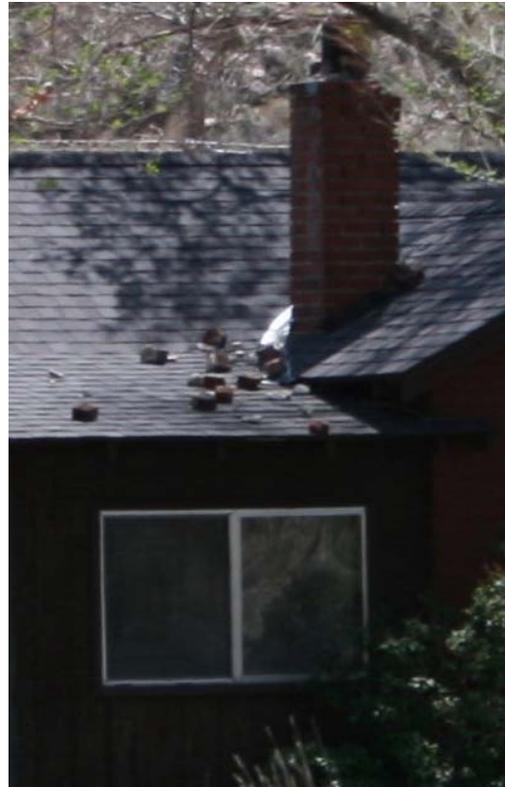
House chimneys fared well during the earthquake, although there was at least one that spilled some bricks from its top (**Figure 42**). Most chimneys in Mogul and Somerset are not made of brick, however, but are wood exterior boxes with metal stove pipes going up them, so they are not as susceptible to shaking as brick chimneys (they are relatively light, flexible features).

**Figure 42** Several bricks were thrown from this chimney near Mogul.

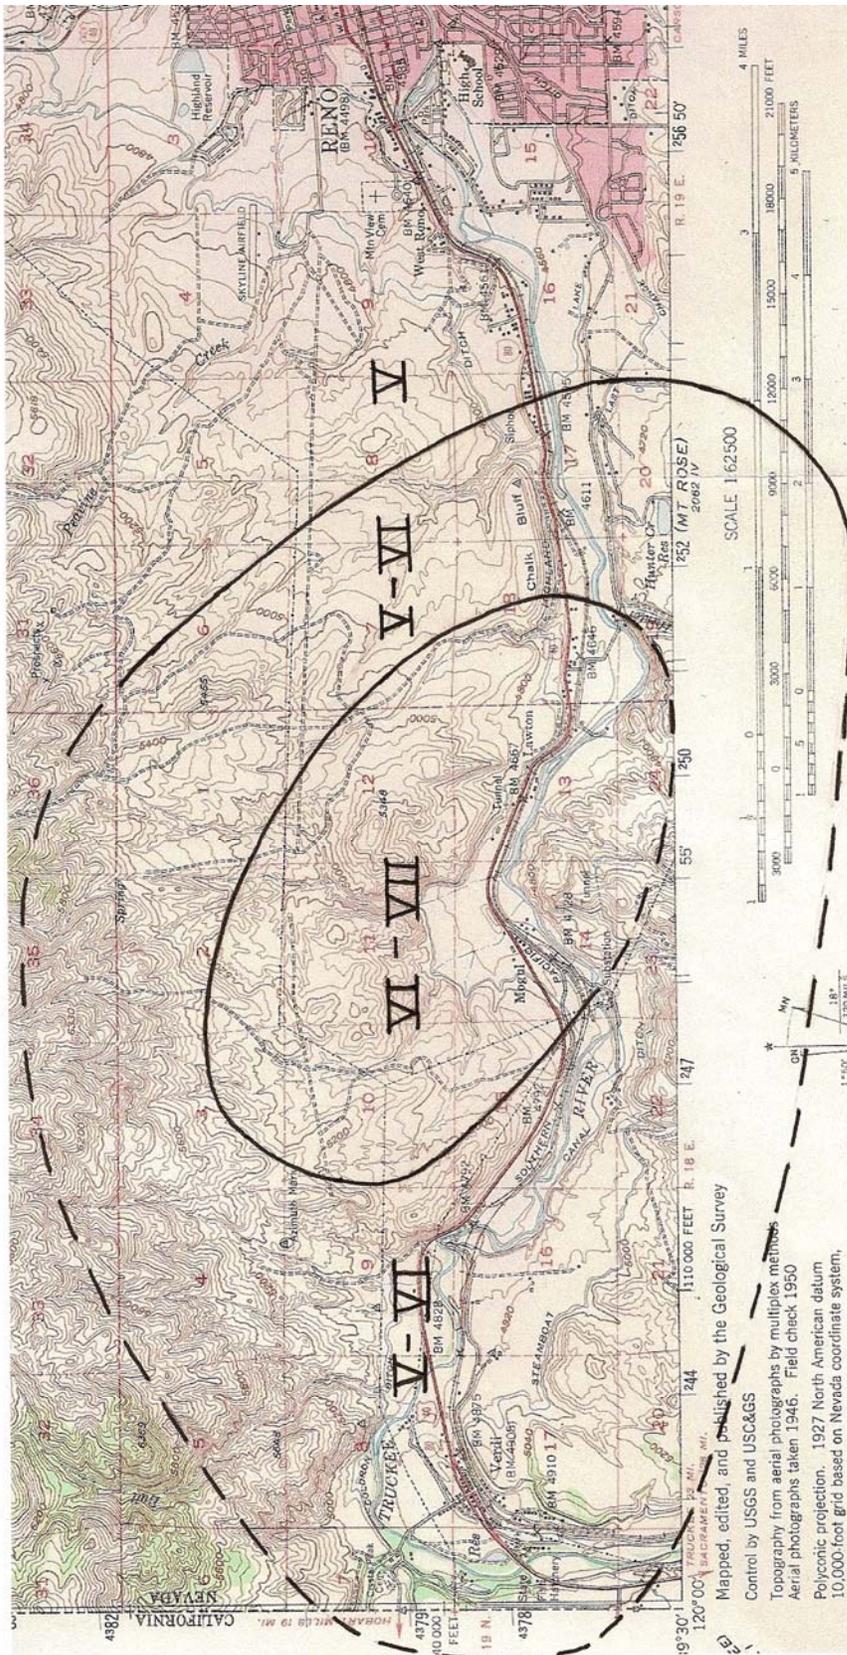
A preliminary Modified Mercalli Intensity map (**Figure 43**) for the April 25 earthquake is based on observations and reported effects from this earthquake (Modified Mercalli Intensity is a measure of the effects on people and structures from an earthquake). All the lines are approximations. To help account for the uncertainties involved and the gradational nature of these boundaries, ranges of intensities are assigned to areas. There was some wall base damage and some minor damage to at least one chimney, so Modified Mercalli Intensity VII was being approached (intensities are given in Roman numerals). There were cracked walls and a few cracked windows in Mogul and Somerset indicating an intensity VI. Immediately outside of the damaged areas, people

Intensity VI to VII effects occurred in Mogul, upper Mogul (immediately west of Mogul), and part of Somersett. In the neighborhoods between Somerett and roughly Rob Drive to the east there was a lot of nonstructural dislodgement, but wall cracking was isolated. In this area and in Verdi, nonstructural dislodgement and damage was more pronounced in second stories of homes and buildings. The USGS Community Internet Intensity Map indicates that intensity V was experienced throughout the greater Reno area.

**Figure 43** Modified Mercalli Intensity Map for the April 25<sup>th</sup> (PST) moment magnitude 5 earthquake. Intensity V is felt by all and people who are asleep were awakened by the shaking. Intensity VI is shaking that knocks items off shelves and creates some cracking in walls. Intensity VII is shaking severe enough to damage chimneys and walls; in a few cases damage was on the threshold of Intensity VII. The lines are dashed where they are less certain.

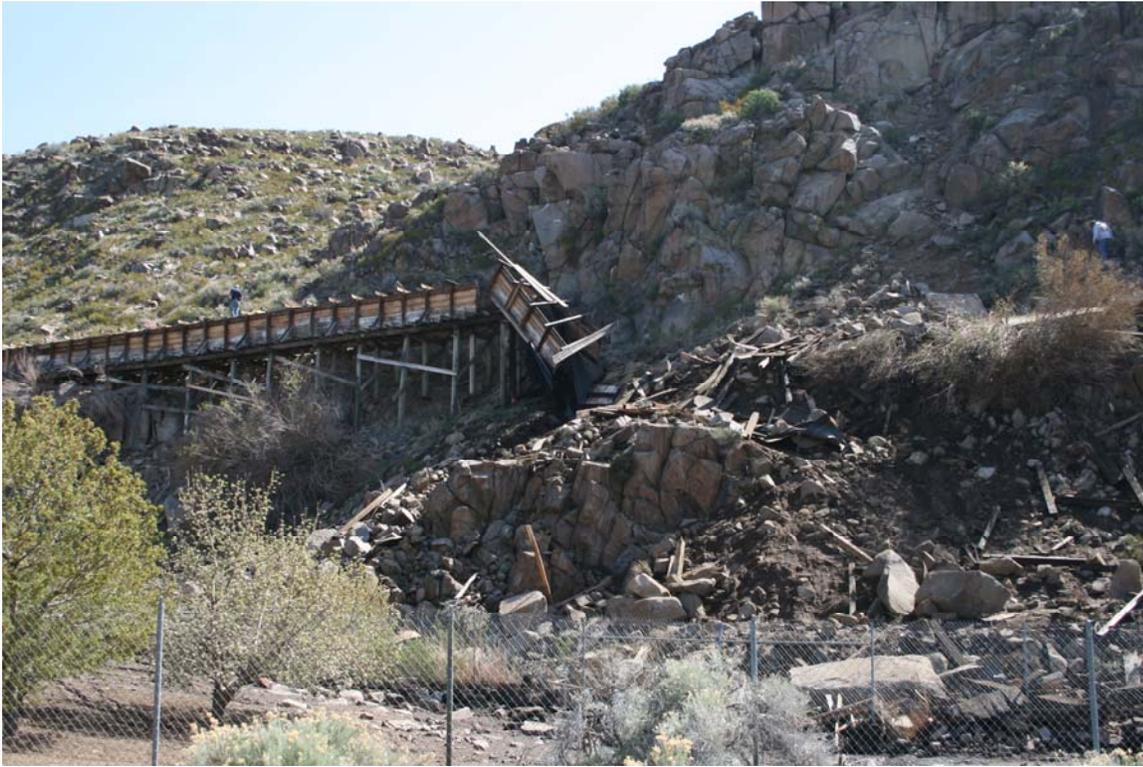
Only one utility appeared to have been damaged by the earthquake, a water canal used as a source for a local water treatment plant. An elevated and trussed section of the canal was struck by a rock fall and collapsed (**Figures 44, 45, and 46**). There are alternate water sources for the treatment facility, but the canal is needed for the increased summer water usage so a chain link blanket was lowered by helicopters to secure the slope from future earthquakes (**Figure 47**).

**Figure 44** Rock fall damage to water flume.

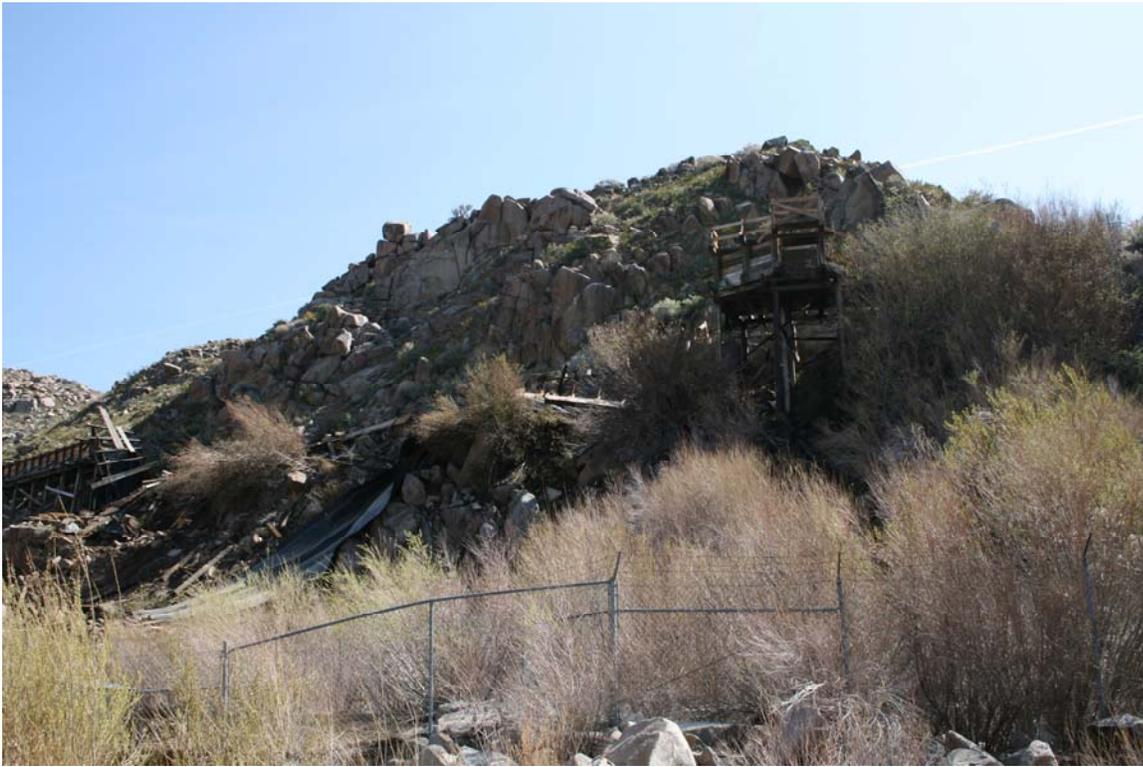
**Figure 45** Rock fall damage to water flume.

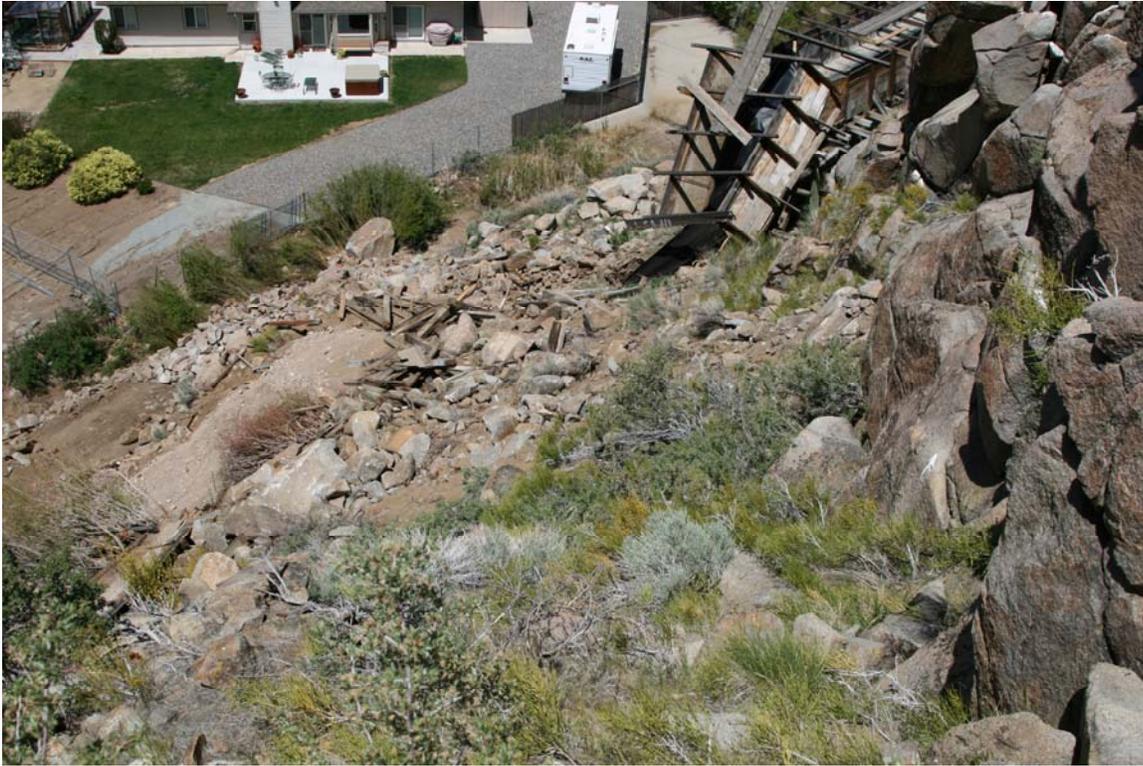
**Figure 46** Part of the rock fall that damaged water flume.

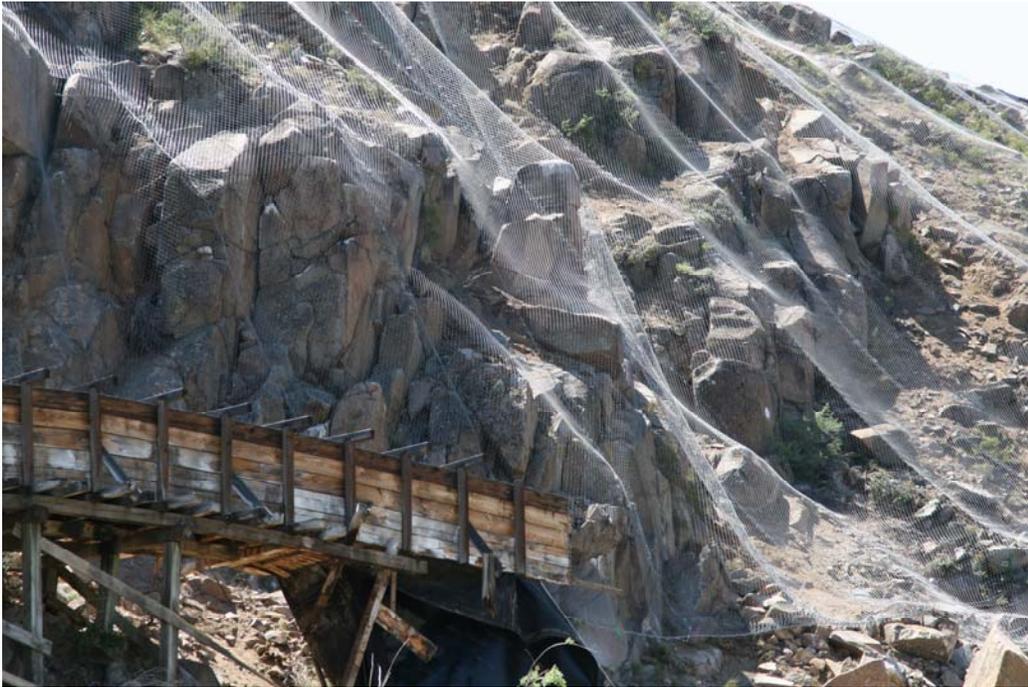
**Figure 47** Mitigation technique used to secure the rock-slope against future earthquakes. Two large helicopters dropped this chain-link netting over the outcrop.

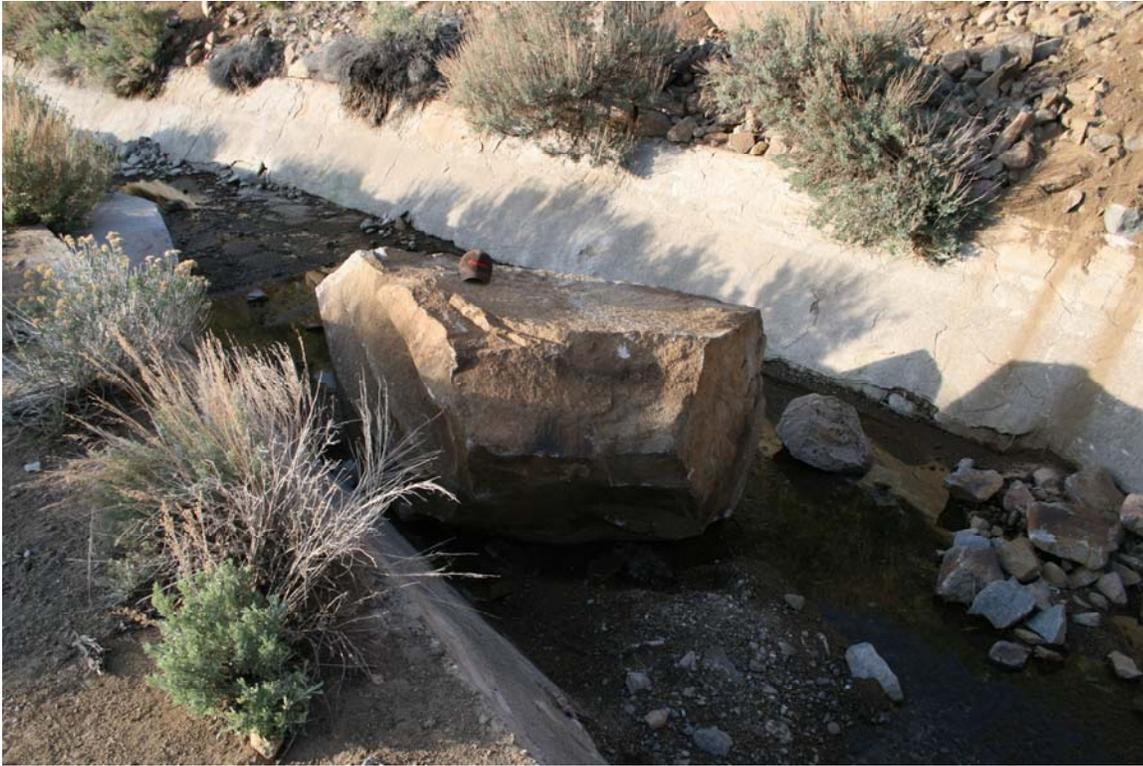
**Figure 48** (above) A large boulder was dislodged by the earthquake, rolled down the hill, and was fortunately caught by the water canal, as there are houses below.

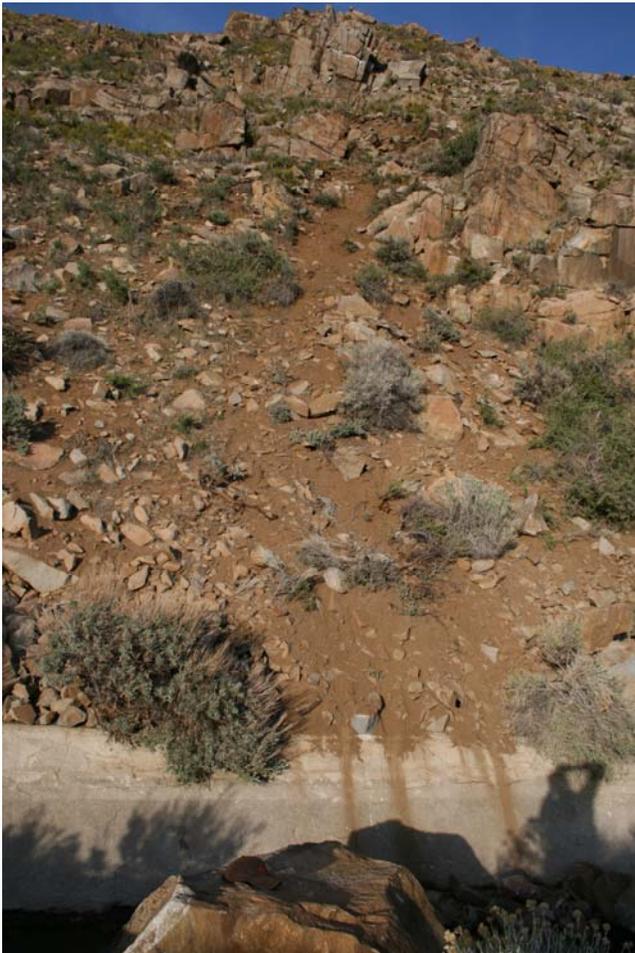
**Figure 49** Cleared dirt path made on the hillside from the boulder shown in figure 48.

Elsewhere, numerous rocks were “caught” in the canal, some of these would have traveled into a neighborhood had they not been stopped by the canal (**Figures 48, 49, and 50**). The rocks will have to be cleared before the canal can be used again.

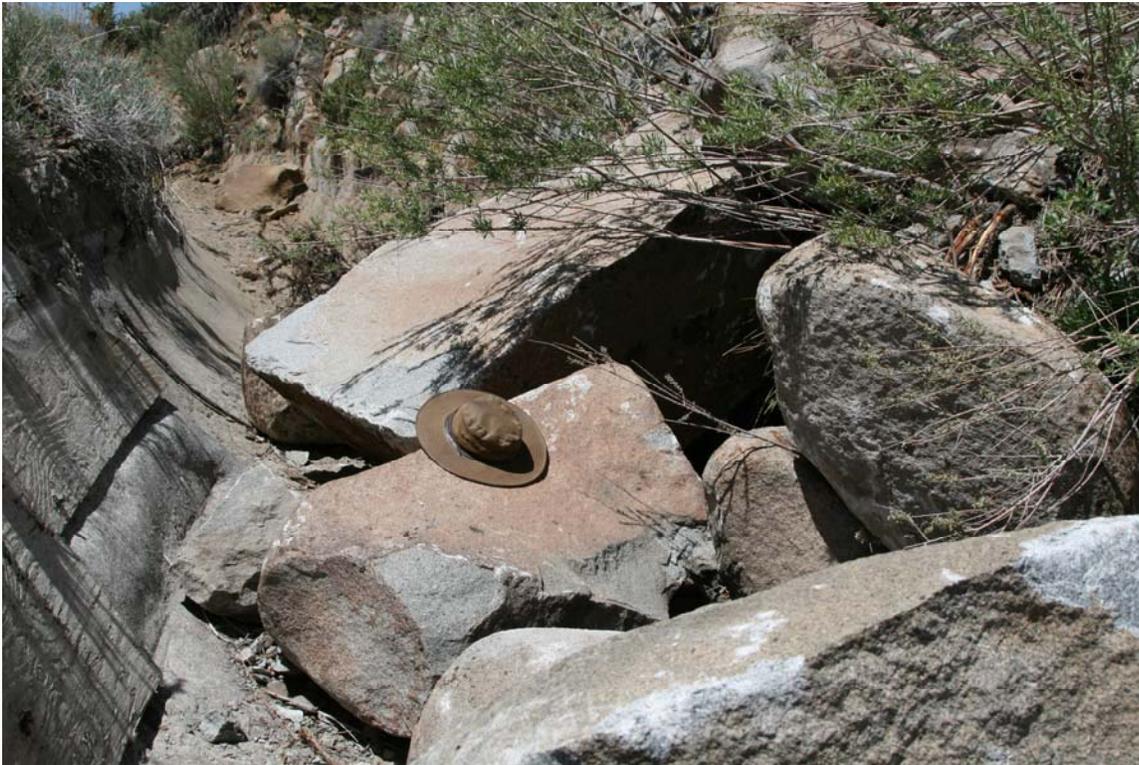
**Figure 50** Rock slide of boulders that were coming down the hill and were trapped by the water canal.

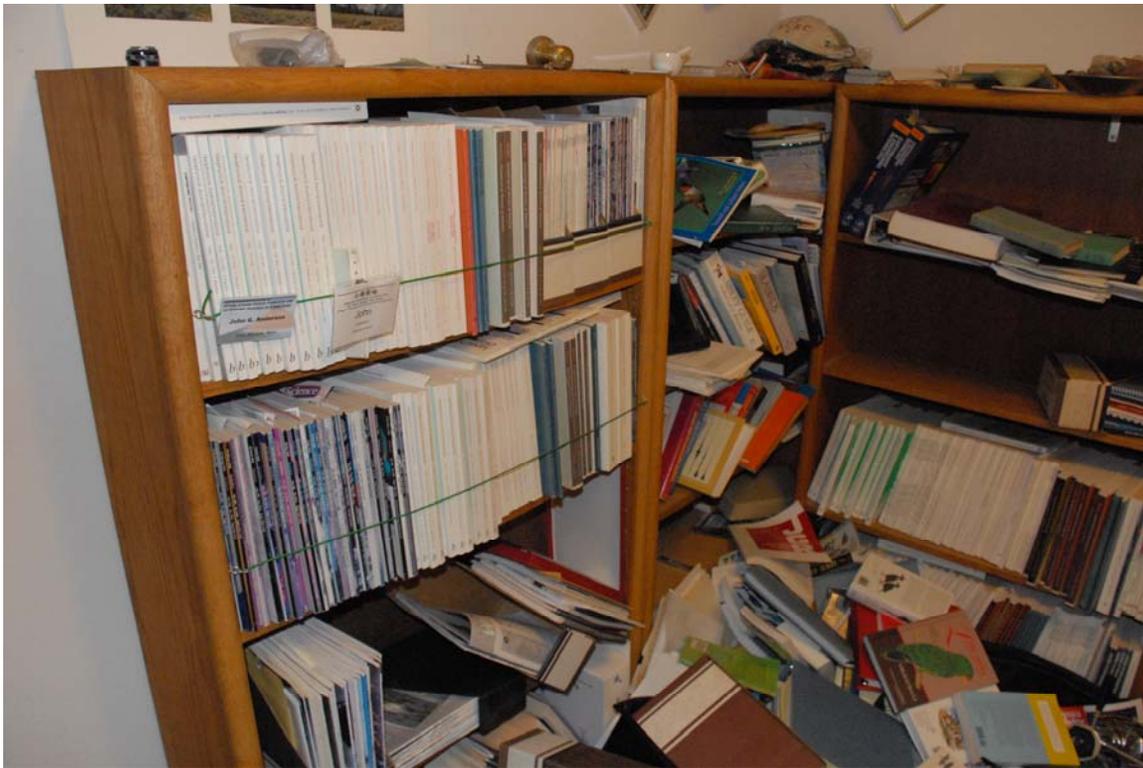
**Figure 51** Mitigation works. Mitigated, more-valued journals stayed in shelves, whereas less-valued journals need to be re-shelved following the earthquake. This house was near the epicenter. (photo by John Anderson)

Many people took these messages to heart and mitigated nonstructural hazards prior to Friday night’s earthquake (April 25<sup>th</sup>). In one case an individual, who lives near the epicenter of the mainshock, strapped up his water heater (along with others) the day of the earthquake (likely motivated by the two M4 events on April 24). Consequently there were many items moved to safer locations or secured that were saved from damage, loss, and creating injuries or hazards (**Figures 51, 52, and 53**).

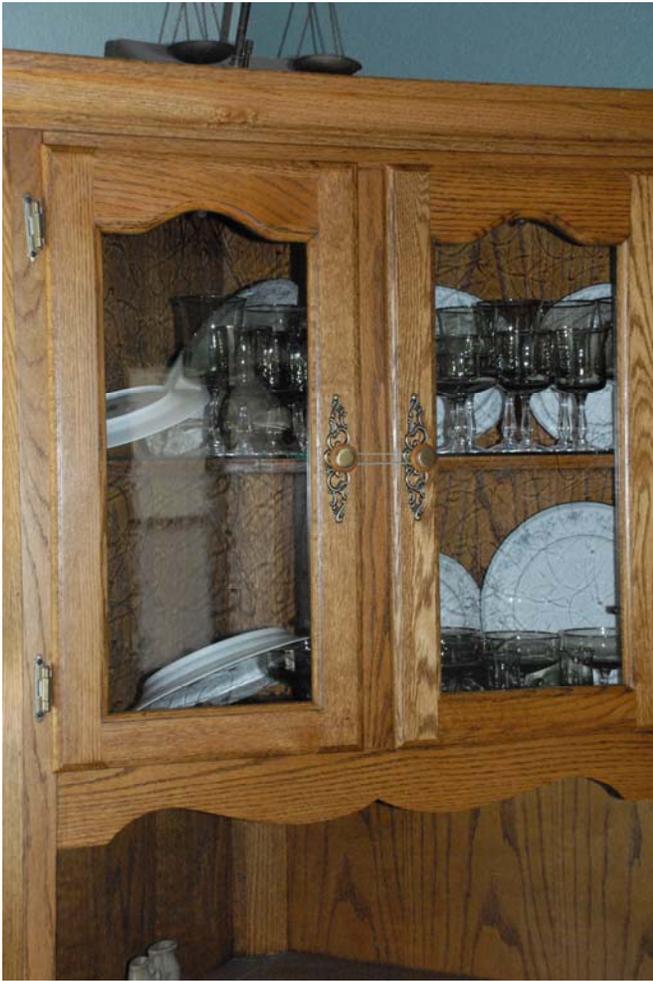
**Figure 52** Simple mitigation for china cabinet used by many local residents. In this case, a simple rubber band that you might find around a newspaper saved dishes and glasses from falling to the floor and breaking during the Mw 5 earthquake. The cabinet was not anchored to the wall. (photo by Gesila Anderson)

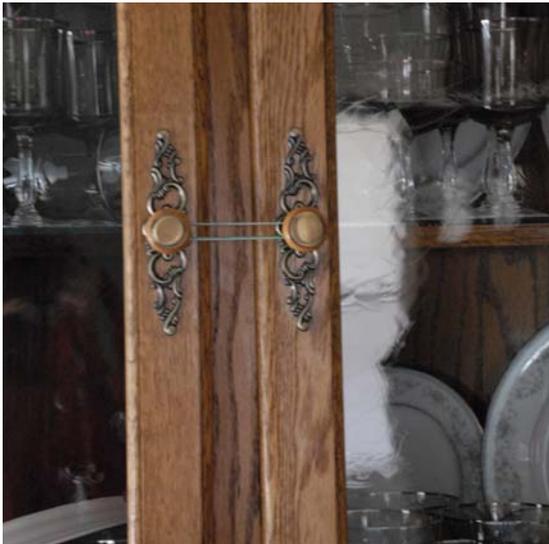
**Figure 53** Detail of the rubber band that defeated the magnitude 5 earthquake shown in figure 52. (photo by Gesila Anderson)
